# Damage Control

## Test Case

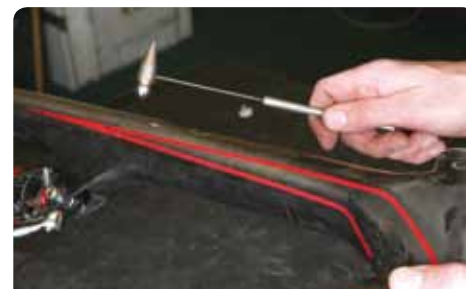
**Acoustic testing can detect internal delamination, but only where the damage affects a reasonably large area. By comparison, ultrasound can reveal the tiniest discrepancy.**

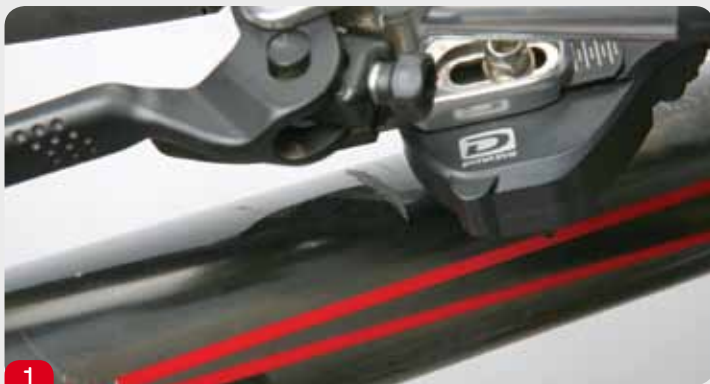
1

I damaged the frame when I crashed and the gear shifter pod slammed into the top tube. Normally I'd have the brake/shift lever tight enough to stay put but loose enough that they'll move in a crash before damaging the frame or breaking themselves. For whatever reason I'd done my levers up too tight and the head of a bolt on the shifter gouged the top tube. Over four years of general trail riding, my frame had copped plenty of general wear and tear, rock bashes on the down tube, chain suck and so on. In this case, the depth of the gouge concerned me, as I know the Spark is such a lightweight frame; at 1,830g including the shock there can't be much wall thickness to the frame tubes. To start with I e-mailed a sharp close-up photo to Raoul and he suggested that it warranted inspection.

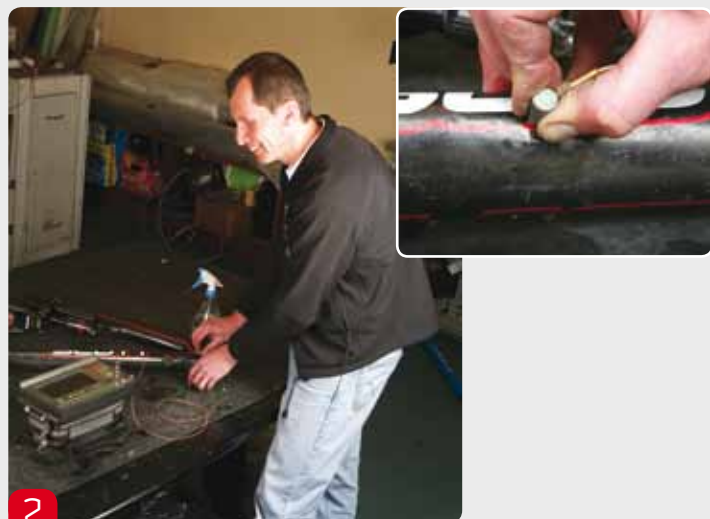
2

While the inspection technique varies depending on the part, ultrasound is probably the most common method used. Ultrasound lets Raoul gauge the wall thickness and assess the integrity of the carbon. Internal delamination, porosity, air bubbles and bonding issues will all show up as an 'indication' on the readout—if you know what you are looking at. Indications as small as 3mm or a single ply of damage in the layup can be detected—it is extremely sensitive.

The ultrasound revealed that the top tube on the Spark averages just 1.0 to 0.9mm thick and the gouge had gone through four plies of carbon. Each ply is approximately 0.1 to 0.13mm thick, so the damage had compromised close to 0.5mm of the carbon—that's around half the wall thickness on the Spark and definitely something to worry about. Raoul also checked right over the frame, looking for any other damage. He didn't find structural issues in other areas, so the frame was well worth repairing.

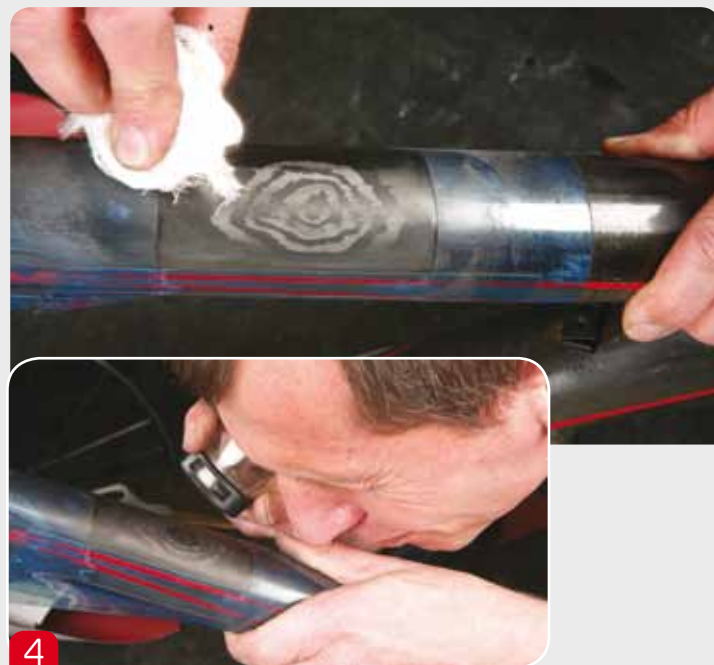
4

After a wipe over with a solvent to remove any residue, you get a much clearer picture of the frame construction. It's now easy to see all the different layers or plies of carbon that make up the frame tube. Raoul now gets in close with a magnifying glass and notes the number of plies, as well as the orientation of the fibres in each ply. Unidirectional carbon forms the structural heart on most carbon bikes and the direction that the fibres travel in determines the performance characteristics of each part of the frame. Diagonal placement of the fibres provides more torsional stiffness while linear placement limits longitudinal stretch. Taking note of the fibre orientation means the patch can be matched to produce the same performance characteristics as the original frame material. In addition to retaining the same ride quality, matching the strength and stiffness ensures the patch doesn't place undue stress on the surrounding material.

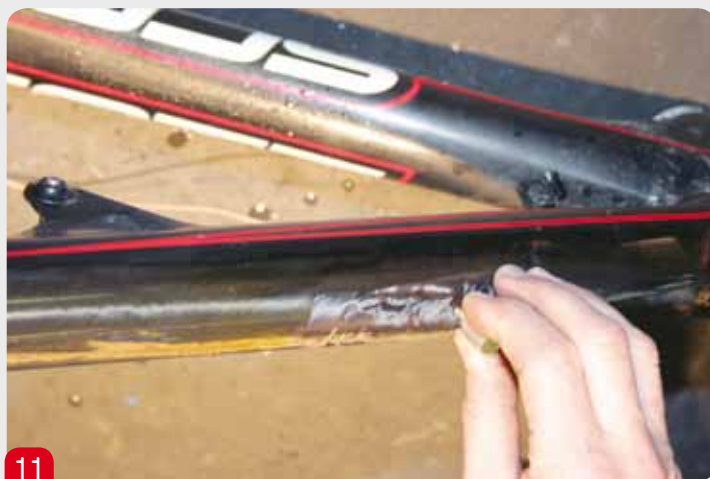
**U**sually done before the painting, Raoul will inspect the finished repair with ultrasound. This will reveal if there were any vacuum/compaction issues when it was in the oven or if any plies in the patch shifted inside the bag. Carbon fibre is extremely strong, but only when the fibres themselves are laid out in a straight and consistent manner. The final inspection ensures there are no kinked or folded plies within the repair. While you can see the repair patch through the clear coat, it is smooth to touch. The repair doesn't look that different to the rest of the finish, which like most unidirectional carbon bikes, is a patchwork of different plies anyway. Frames that have a more consistent woven finish can also be matched with the same 3K, 6K or 12K carbon used on the visible outer layer.
